# ERTEC Environmental Systems

## Case Study

Application: Gully Stabilization  
Product: ERTEC Gully Stabilization System™ (GSS™)  
Location: Lake Chabot, Hayward, CA  
Customer: East Bay Regional Park District

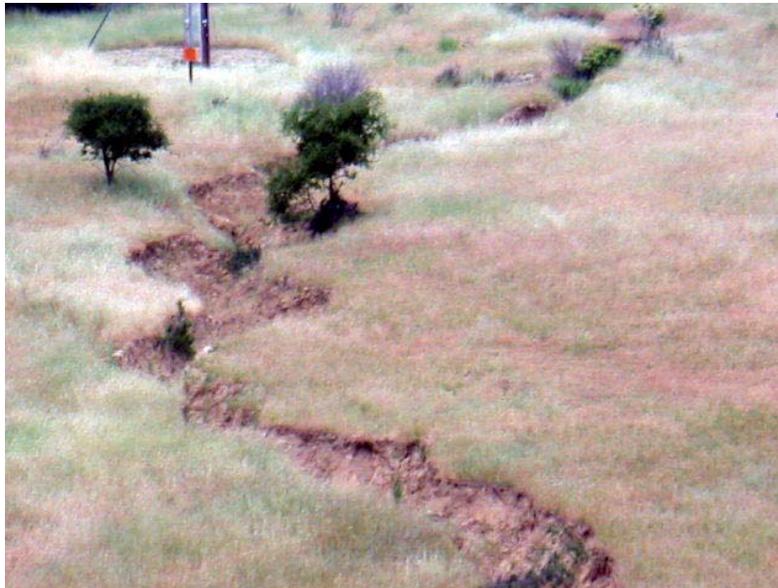
**Gully System: 400 feet long, 100 feet high**

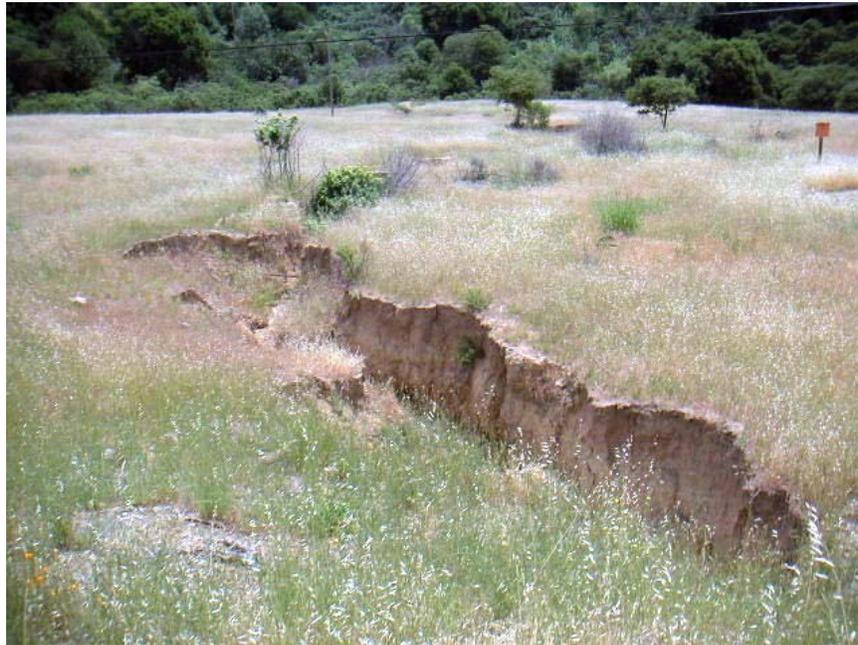
**Pre-project site conditions**

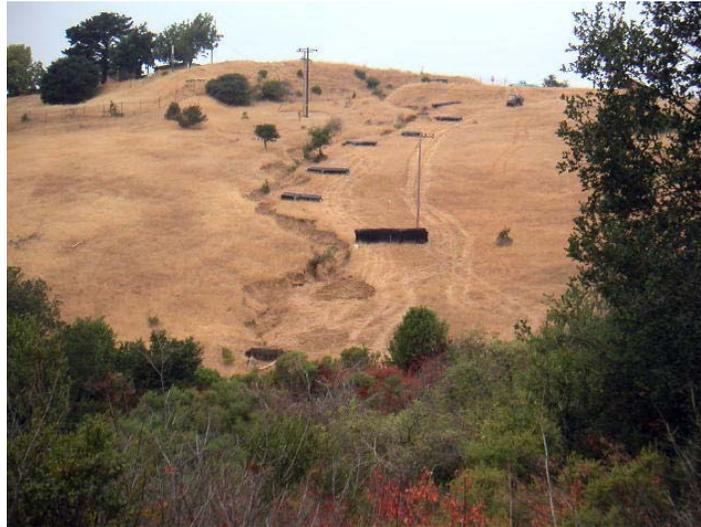
**Nine structures ready for installation**

<b>Solution</b>	<p>According to proper Gully Stabilization Design principles, the 4 foot structures should be placed at 12 to 14 foot intervals on a 25% slope. By placing at these intervals, the top of the downstream structure would be level with the base of the upstream structure. This would allow water coming over the top of the upstream structure to flow into the pool created by the downstream structure, to absorb the erosive energy at the water drop and eliminate head-cutting between structures. Due to limited resources it was decided to reduce this interval by two thirds. It was understood that this method could still enable stabilization, but that some head-cutting would still occur between structures threatening structures upstream. It was decided that the system would be monitored closely and additional structures would be added on an as needed basis.</p> <p>The erosion-control structures selected for the project were one-foot diameter polygonal modules (Ertec Environmental Systems™) of high-density polyethylene with internal support structures. Each module consisted of 12 4 foot modules length fastened into a mattress shape design (2' X 4' X 6'). Two sets were fastened to each other to increase structural integrity, forming a module two feet thick. To increase soil retention, a 212-micron AOS filter fabric was layered between the module walls. Using a labor crew from the Park District, trenches were dug as required for each structure. A rule of thumb for Gully Stabilization structures is to key-in the structures as follows: Depth = 25% of the height of the structure. Width – key in 25% of the Gully Width (mid-depth) on each side. Initial clearing of debris and soil excavation provided a level footing to set the modules. Geotextile was placed under the structures, to prevent piping or undermining. The modules were then butted up against each other as needed across the width of the gully (typically 2 or 3 modules wide) and anchored with steel T-Posts. As a last step, because it was readily available, crews positioned rock immediately downstream of the structures. The heavy storm season conditions of 2005 indicate the structure held up well against heavy flow and sediment load.</p> <p>A soil analysis was not completed but it is expected that the Gully soil could be classified as Clay or Silty-Clay loam, although varying with depth.</p>

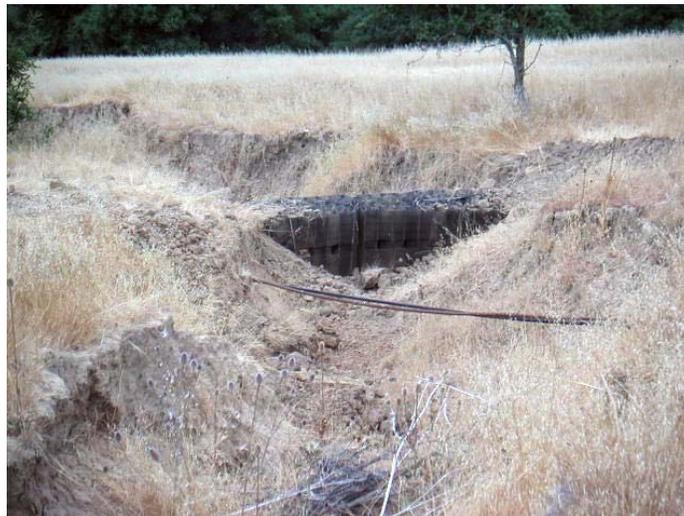
**Structure 4: Installation complete August 2004**

<p>Summary</p> <ul style="list-style-type: none"> <li>• 2" X 4' X 6' GSS modules. 2 or more modules installed in each check-dam – depending on width of gully.</li> <li>• 9 Check-dam structures</li> <li>• Use of park labor crews to install, 1 day with excavation equipment</li> <li>• Check-dam anchored and secured with 5 foot metal t-posts driven flush with top of check-dam structures</li> <li>• Because it is readily available, rock was placed downstream of each structure to act as a splash apron, to help remove erosive energy from the flowing water.</li> <li>• Geo-textile fabric was installed underneath, upstream and down stream of check-dam</li> </ul>
--	---

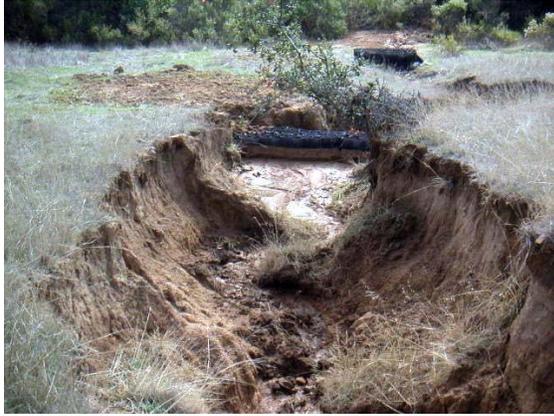
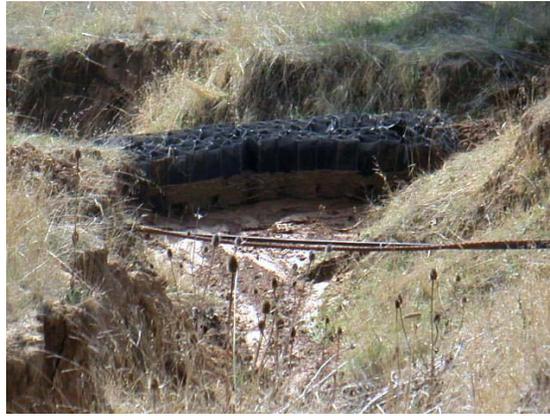
**Oct 2004: Post-storm: Structures 8 and 4**

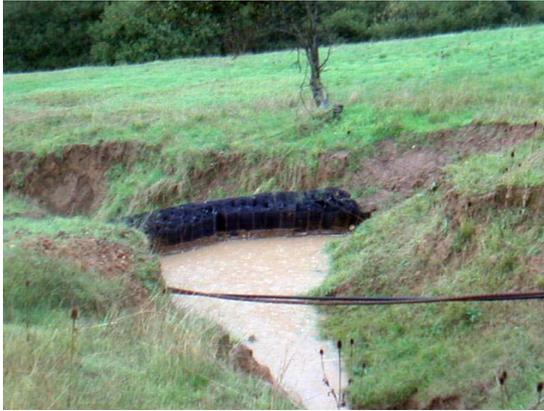
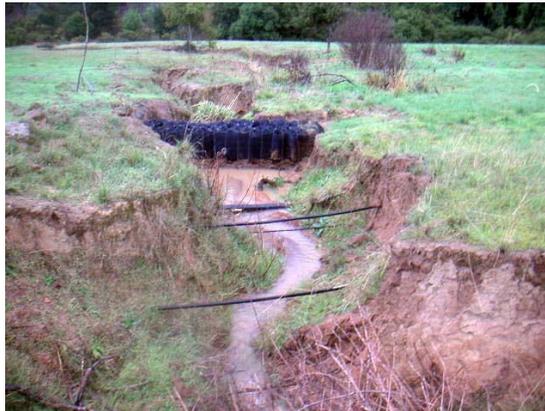
**Dec 2004: During storm: Structures 4 and 7**

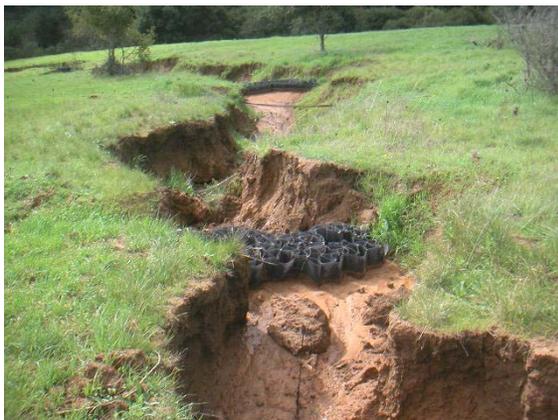
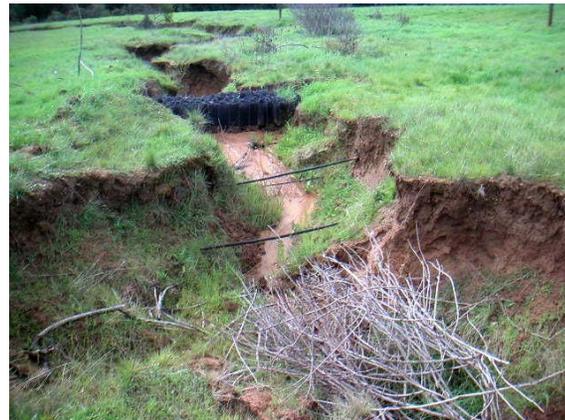
**Feb 2005: Structures 3, 4 and 7**

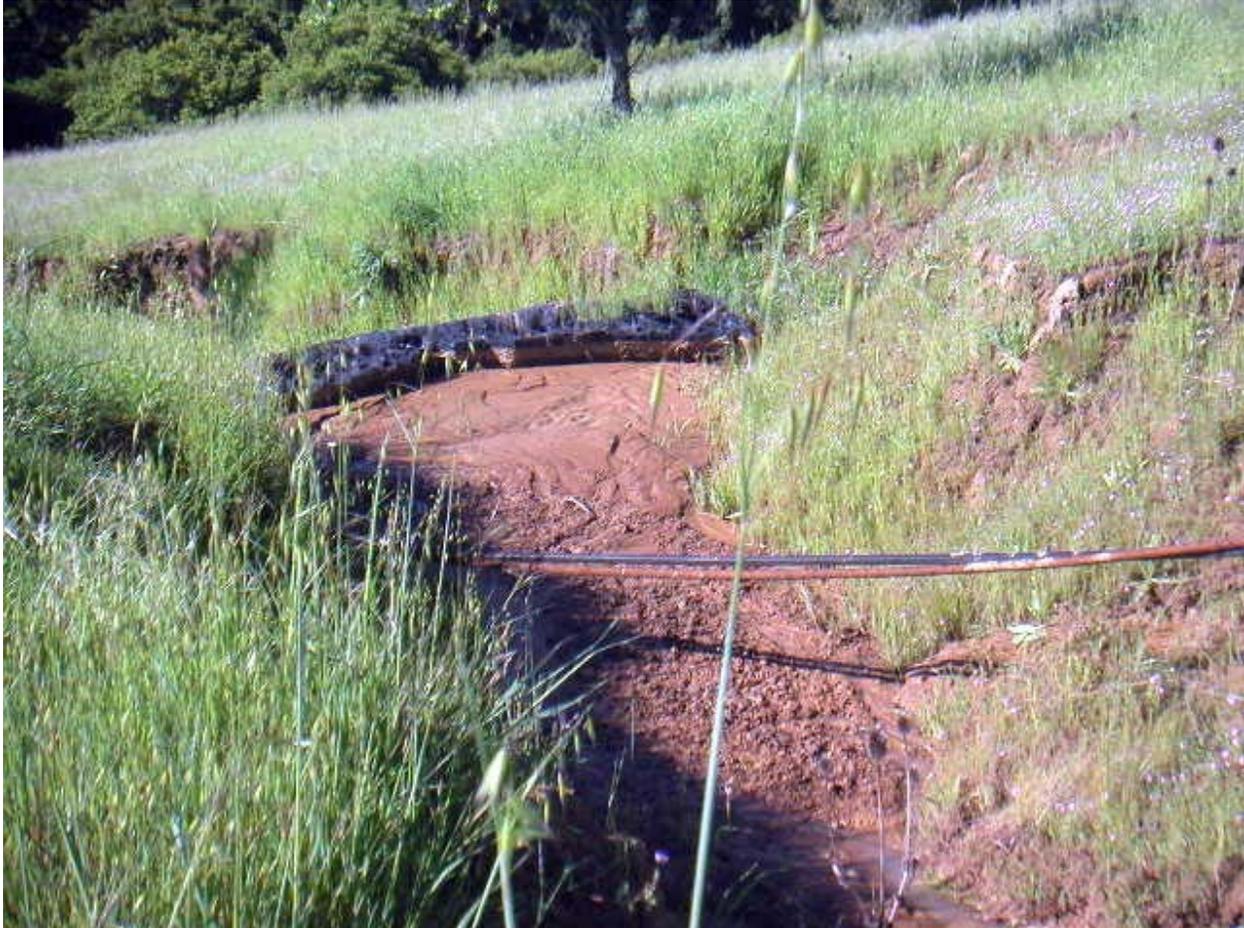
**April 2005: Structure 4**

<b>Results</b>	<ul style="list-style-type: none"> <li>• After the first storm season (Winter 2004/05 had significant rainfall) – gully down-cutting has stopped</li> <li>• Ertec Gully Stabilization Systems remain solidly in place</li> <li>• Sediment to the lake significantly reduced</li> </ul>
<b>Customer Quotes</b>	<p>“We’re very happy with the installation. The gully appears to have stabilized, and the sediment load to the lake has been reduced drastically. We believe this is the best way to eventually restore vegetation in the channel, and eliminate this as a concern for Park Management.” - Joe Britton, Supervisor Lake Chabot Park</p>
<b>Summary</b>	<p>This was a successful program for the following reasons:</p> <ul style="list-style-type: none"> <li>• Low cost</li> <li>• Simple installation</li> <li>• Robust solution</li> <li>• Immediate reduction of erosion and land loss</li> </ul>
<b>Future plans:</b>	<p>Install additional modules where the downstream modules are at capacity, and where substantial amount of upstream sediment load from collapsing banks continues. As the banks slump and reach their angle of repose, the park will seed to encourage robust vegetation growth.</p>
