ERTEC Environmental Systems

Case Study

Application: Stabilize Bank of Permanent Roadside Water Treatment Basin
Product: Bank Stabilization System™ **Date:** Summer 2006
Location: Lake Tahoe—Douglas County, Nevada
Customer: Logan Creek Estates General Improvement District
Engineer: JWA Consulting Engineers, Inc.
Contractor: V&C Construction, Inc.
Funded by: Tahoe Bond Act, Nevada Division of State Lands, U.S. Forest Service, Nevada Division of Environmental Protection

Project description and background

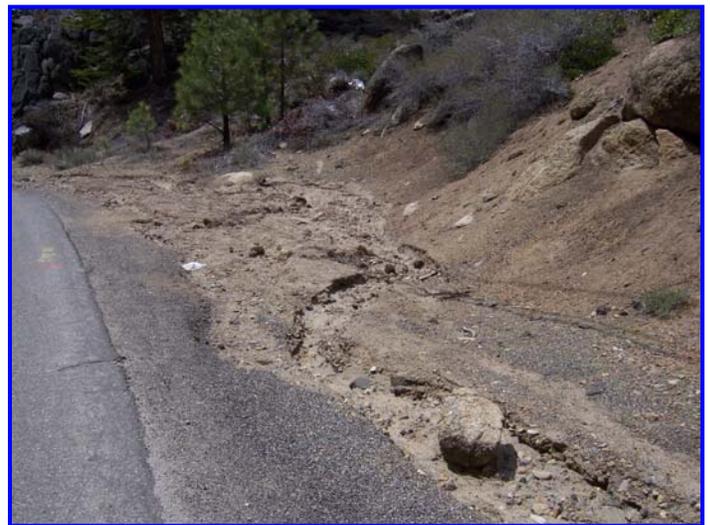
Fig 2: Pre-conditions. Location of proposed basins

In one section of the project, in order to improve drainage adjacent to the road, two small water quality treatment basins were proposed within the right-of-way. With limited room for proper basin sizing, it was necessary to create steep slopes (1:1) to attain the required basin depth and volume. The steep slopes would potentially leave the adjacent road vulnerable to erosion mechanisms such as scour, sloughing and undermining. To protect the road, ERTEC's Bank Stabilization Modules were imbedded into the slopes, completely covered and vegetated. Additionally, to enhance drainage from the water treatment basins, permeable berms were created at the downstream ends of each of the basin, by installing the BSS system and filling with drain rock.

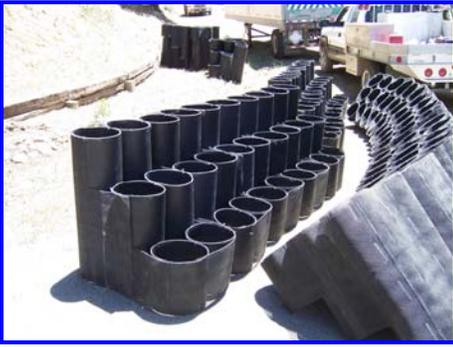
Figure 3: Section assembly

The erosion-control structures selected for the project were one-foot diameter multi-cylinder modules (ERTEC Environmental Systems) of high-density polyethylene (HDPE). For Bank Protection—each set consisted of one 1’, one 2’, and one 3’ length cylinders fastened into a staircase buttress design. Two sets were fastened to each other to increase structural integrity, forming a module two feet wide. To increase soil retention, a 200-micron AOS filter fabric was layered within the cylinder walls. Initial soil excavation provided a level footing to set the modules. The perimeter surfaces and bottom of the modules were wrapped with a non-woven filter fabric to provide additional soil retention. The Berm system structure was similar but contained an additional 4’ cylinder. The Bank system was filled with sand slurry pumped in with a concrete pump. The two Berm systems were filled with drain rock. As installation was completed, crews back-filled the modules and voids with loose soil and compacted it. As a last step, crews shaped the two water treatment basins, installed re-vegetation and erosion control blankets throughout the basins.

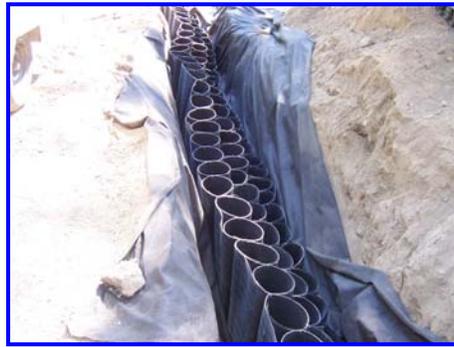
Figure 4: Section placement—post trenching—bank protection

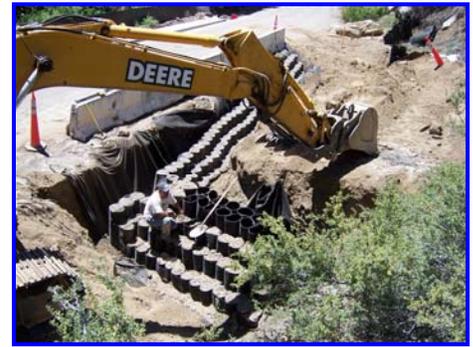
Figure 4: Filling of inter-basin berm trenching

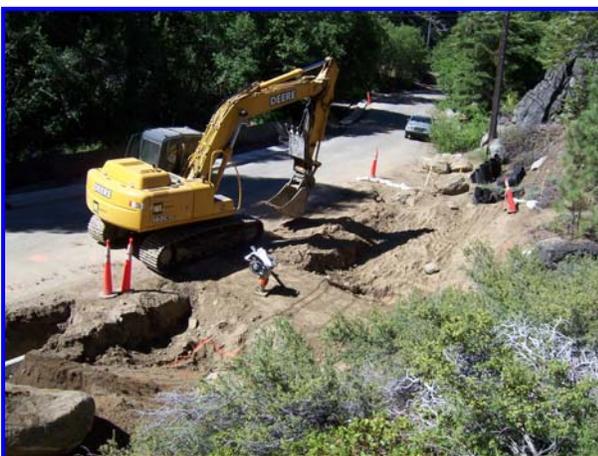
Figure 5: During backfill and basin forming

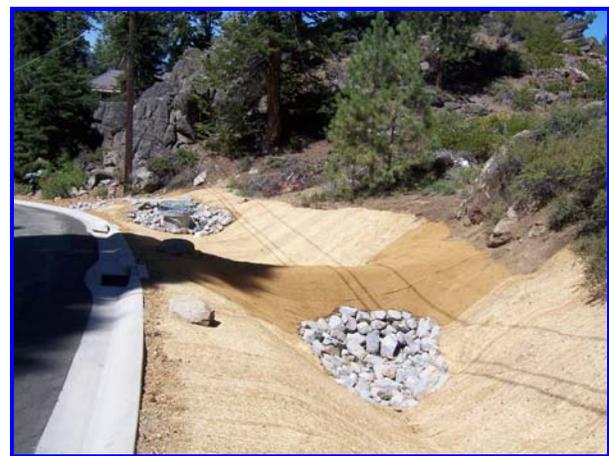
Figure 6: 2 months after installation
