ERTEC Environmental Systems

Case Study

Application: Bio-Technical River Bank Stabilization
Product: Bank Stabilization System™
Location: Decker Island Levee Bank Stabilization Project
Customer: State of California Department of Water Resources
Delta Levees Program
Installation: October 2002

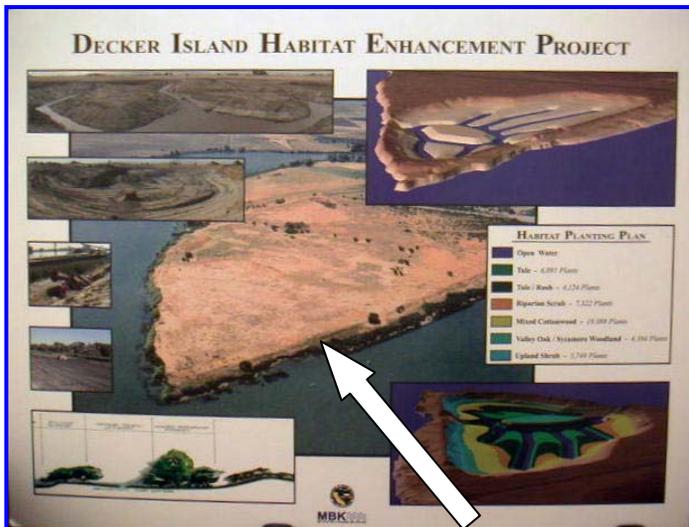
Figure 1: Location of ERTEC project on Decker Island

Exposed bank (see white arrow in Figure 1) – at northwest tip of Decker Island on Sacramento River – original rock-retaining berm washed away. Heavy, swirling currents, heavy winds and large pieces of driftwood serve to scour shoreline away at a rate of 5 ft per year.

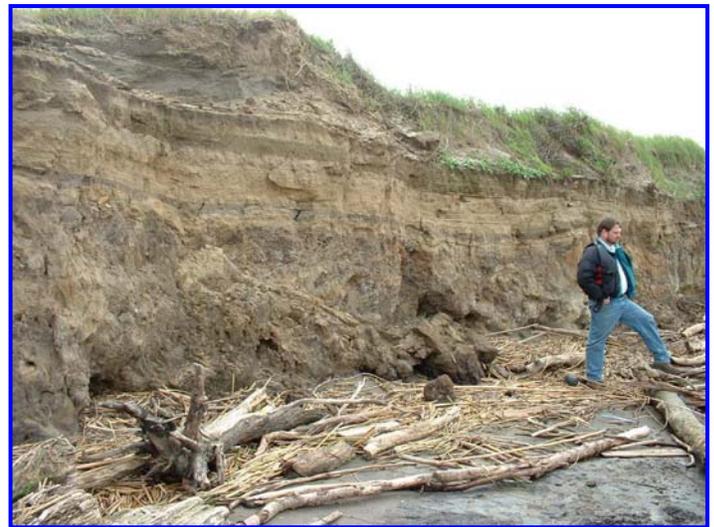
Figure 2: Pre-project site conditions

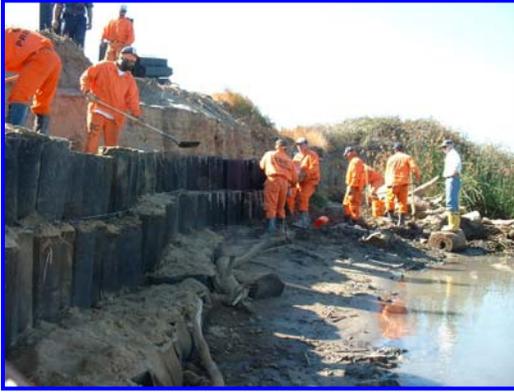
Figure 3: Installation in progress

The erosion-control structures selected for the project were one-foot diameter polygonal modules (ERTEC Environmental Systems) of high-density polyethylene (HDPE). Each set consisted of two 2', one 4', and one 6' length fastened into a stair-case buttress design. Two sets were fastened to each other to increase structural integrity, forming a module two feet wide. To increase soil retention, a 300-micron AOS filter fabric was layered between the module walls. Using labor crews from the Department of Corrections under the supervision of a fire captain from the Department of Forestry and Fire Protection, the project commenced under compatible tide and construction window conditions. Initial clearing of debris and soil excavation provided a level footing to set the modules. The perimeter surfaces and bottom of the modules were wrapped with heavy-duty filter fabric to provide additional soil retention and wave attenuation. The sets were then anchored with stainless steel cable and "duckbills" that were driven 3-5 feet into the face of the bluff. Cables were also wrapped and clamped around adjacent modules. As installation was completed, crews back-filled the modules and voids with loose soil and compacted it with water to create a rigid, but semi-permeable structure. As a last step, crews recessed the top of the bank prior to re-vegetating it with plugs of native grass and willows in and around the modules. Post-storm season conditions 2003, 2004 and 2005 indicate the structure held up well against heavy debris and native grasses and willows are growing profusely creating complex habitat. Flood conditions (high flows, tides and wind) will ultimately determine the utility of this innovative project.

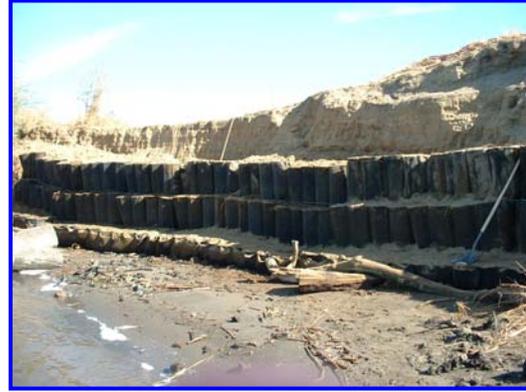
Figure 4: Installation complete

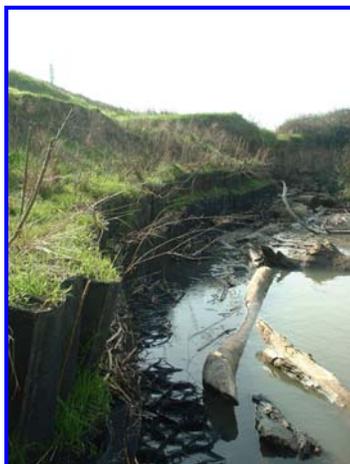
Figure 5: 2 months after install

After three storm seasons – the bank has stabilized. Profuse vegetation is established and riparian habitat is enhanced. Erosion is significantly reduced.

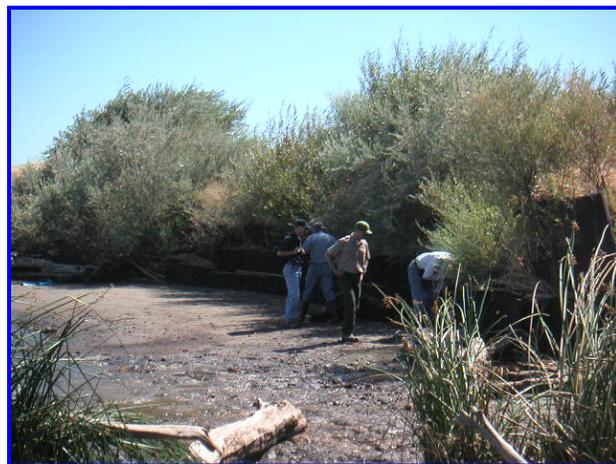
Figure 6: 2 years after installation
