E-Fence™

Wildlife Exclusion Fence

Highway 401 McDougall Drain Bridge Rehabilitation, Widening and Installation of Concrete Median Barrier

HWY 401 Bridge Widening — Ontario, Canada

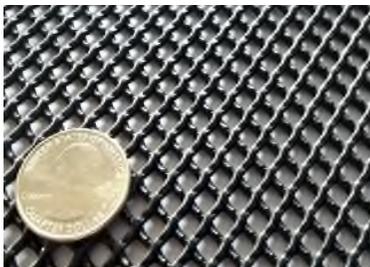
E-Fence HDPE Polymer Matrix

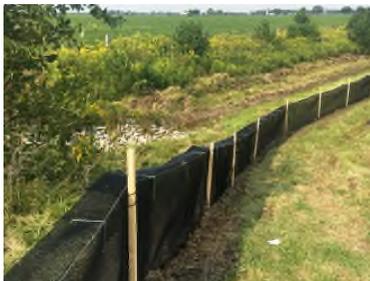
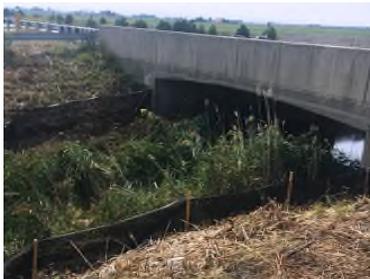
E-Fence shown connecting to and sealing against bridge abutments

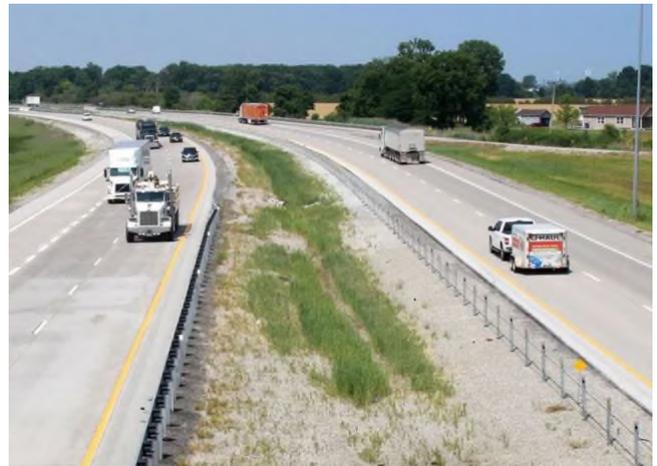
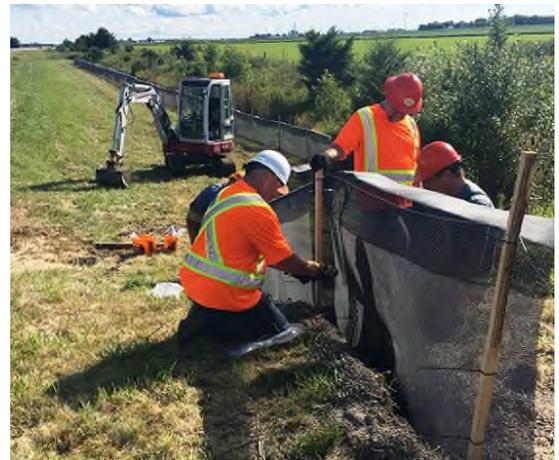
E-Fence installed along the highway right-of-way where it passes through habitat of species at risk

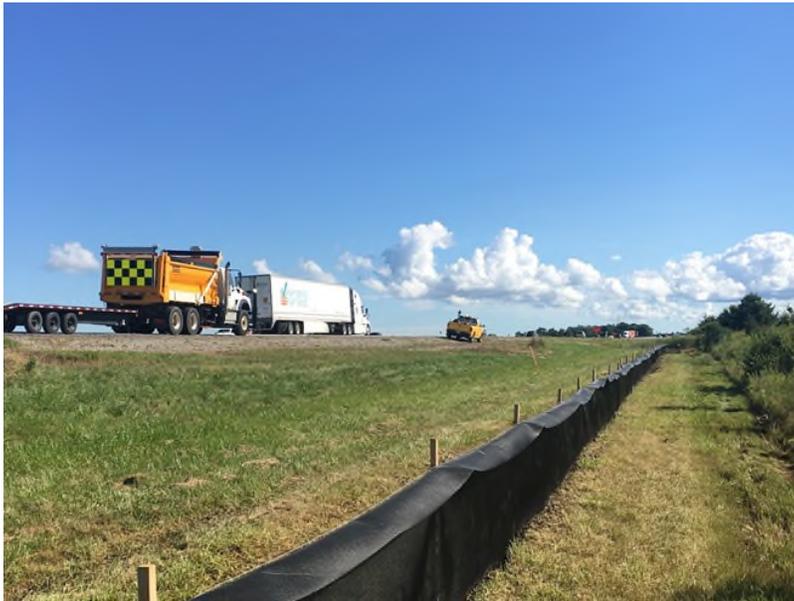
E-Fence installed along the highway right-of-way to keep species at risk out of the construction zone

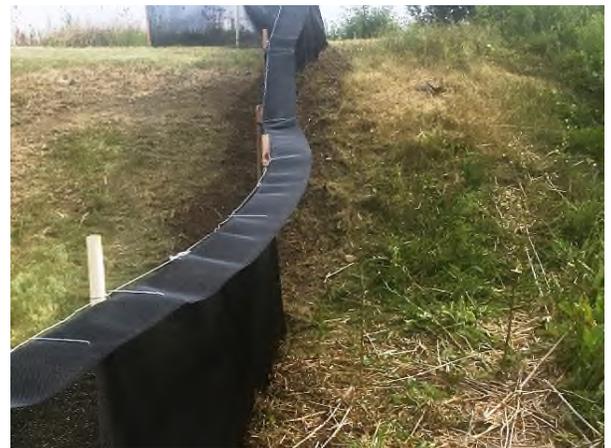
E-Fence installed with an 8" climber barrier. The Eastern foxsnake is an excellent climber. It has been demonstrated that this species cannot climb E-Fence.

E-Fence Anti-Climb Features: [In live tests at Scales Nature Park in Ontario](#), Canada, Eastern foxsnakes (Pg) were not able to climb over E-Fence with a climber barrier. Three aspects enhance the safety factor of E-Fence versus the current standard practice of 2-meter high geotextile fence for the protection of Pg: 1) Pg individuals were not even able to reach the climber barrier. 2) The surface of E-Fence has a very low friction coefficient by design. The snakes were not able to establish suitable contact with the fence in order to climb. They were observed to rise to a certain point but then collapse to the right or to the left. The E-Fence polymer matrix strand angle contributes to the difficulty in climbing. Additionally, unlike mesh fences (such as metal mesh or geotextile mesh) on which the snakes could apply their scutes to the ladder structure, E-Fence Rigid Polymer Matrix presents itself at sharp strand angles which tend to drive climbers to the right or to the left and then down. The snakes could not find leverage to climb. 3) The very high reliability (high functional longevity) of E-Fence (almost no stormwater washouts, or wind knock-downs) as compared to traditional systems leaves significantly less opportunity for a Pg to find a gap in the perimeter barrier and migrate onto a construction site.

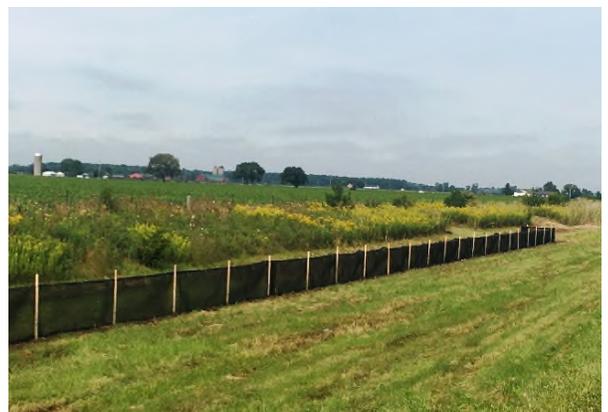
E-Fence installed along the highway right-of-way to keep species at risk out of the construction zone
