## Case Study GR8 Guard™

**Application:** Drain Inlet Protection: DOT Resurfacing Project  
**Product:** GR8 Guard™ for drainage inlets  
**Location:** Highway 280, San Mateo, CA  
**Customer:** Caltrans April, May 2016

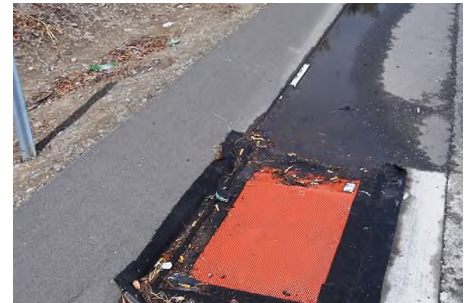
Early in the project

GR8 Guard™ is a patented, low cost, four layer system designed to keep sediment and debris out of grated storm drain inlets in paved areas. The berm layer forces water to rise to at least 1.5 inches before reaching the filter causing heavier particles to settle. The system filters storm water above the ground easing visual inspection and maintenance. The system has a high flow bypass designed to reduce the chance of back ups. It is easy to fasten to the grate with rebar tie-wire, has a long life, is resistant to traffic, and reusable. Grates do need to be removed, during installation or cleaning, reducing installer injuries and worker's comp claims. The units contain recycled materials.

**Solution:** GR8 Guards are attached to the grate with rebar tie-wire at the corners. 430 units were installed by two laborers working separately in 1 week.

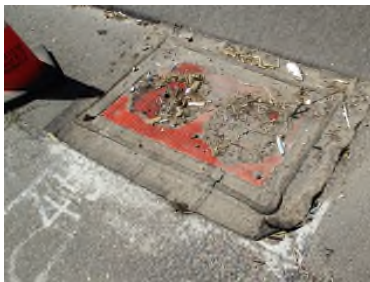
Year 2: Post storm—before cleaning

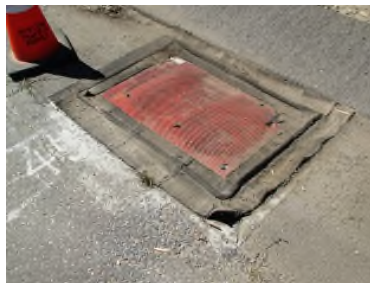
Year 2: Post storm—after cleaning. Grates do not need to be removed for installation or cleaning.
