Case Study GR8 Guard™

Application: Drain Inlet Protection: DOT Resurfacing Project

Product: GR8 Guard™ for drainage inlets

Location: Highway 280, San Mateo, CA

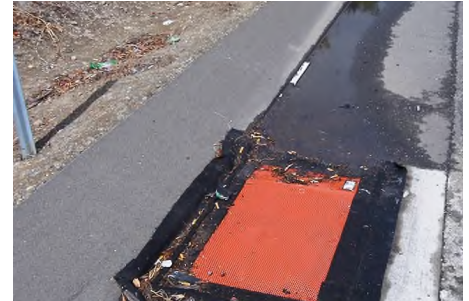
GR8 Guard™ is a patent pending, low cost system designed to keep sediment and debris out of grated storm drain inlets in paved areas. The berm layer forces water to rise to at least 1.5 inches before reaching the filter causing heavier particles to settle. The system filters storm water above the ground easing visual inspection and maintenance. The system has a high flow bypass designed to reduce the chance of back ups. It is easy to fasten to the grate with rebar tie-wire, has a long life, is resistant to traffic, and reusable. Grates do need to be removed, during installation or cleaning, reducing installer injuries and worker's comp claims.

Early in the project

Solution: GR8 Guards are attached to the grate with rebar tie-wire at the corners. 430 units were installed by two laborers working separately in 1 week.
