Case Study E-Fence™

Wildlife Exclusion for
Small Vertebrates

E-Fence™ Triple Function: Exclusion, Hi-Vis Safety,
Sediment Control Temporary Installation

Substation Expansion

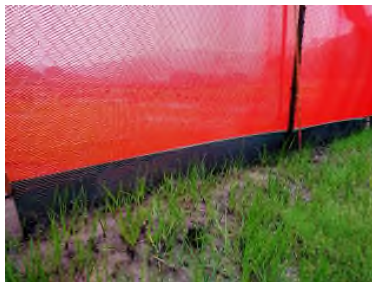
Post Storm

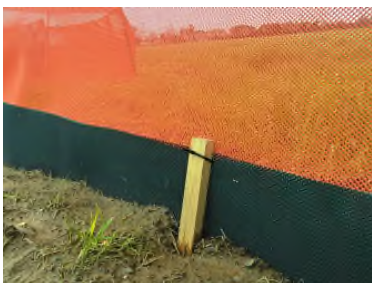
Post Storm

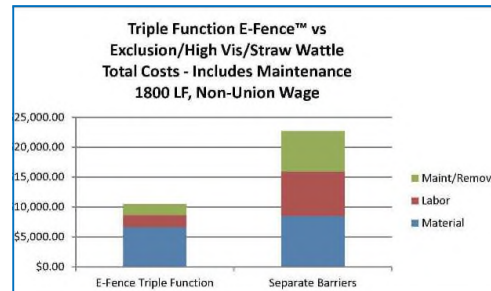
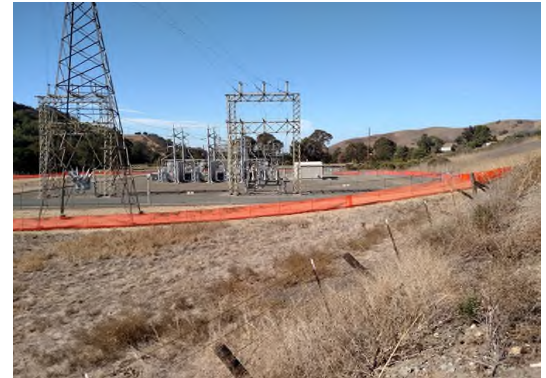
E-Fence Triple Function Barrier Installed Around Substation During Construction

Configuration: E-Fence Orange, 48" width. Trenched 5". ERTEC S-Fence 12" used for sediment control, in the same trench. No climber barrier lip required. Install sediment control only where needed (about 60% of the perimeter).

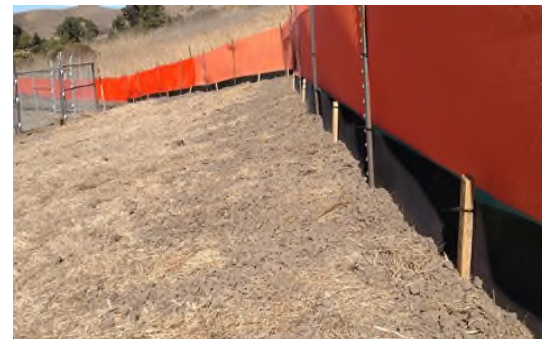
Sediment Control Installed to Control Run-On
