Case Study E-Fence™

Wildlife Containment and
Directional Control

Mountain Lake Restoration

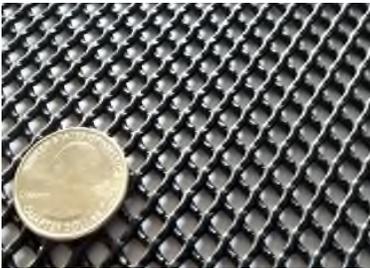
Photo 1: E-Fence™ HDPE Polymer Matrix

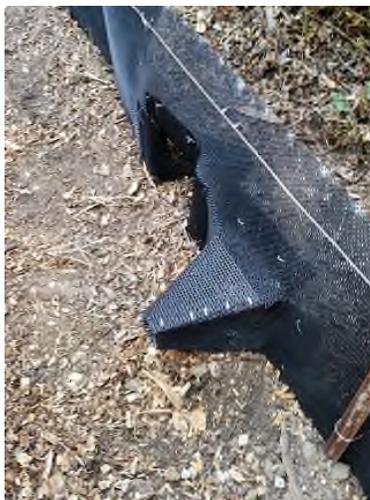
Photo 2: Funnels in both directions allow small animals to move between areas (frogs, rodents)

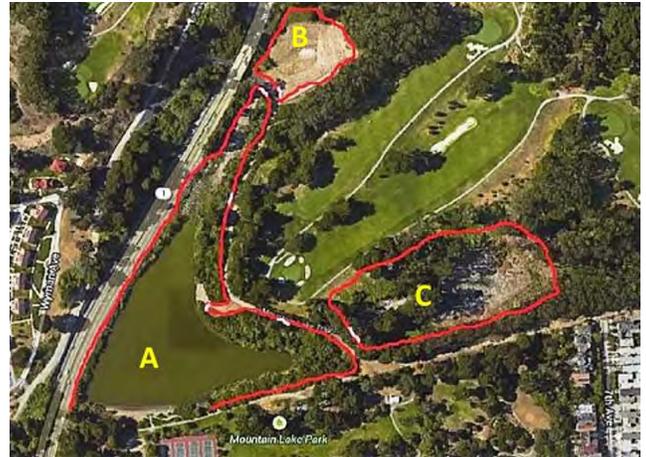
Fig. 1: Area A: Lake and wetlands; Area B: Northern Habitat; Area C: East Arm

Native to Mountain Lake, the Western pond turtle (WPT) and Pacific chorus frog (PCF) were reintroduced. Given all the hazards surrounding the area and with an eye towards protecting the new populations, conservationists hoped to contain them in certain areas and direct them to other areas. A permanent barrier that could function in different ways in different locations was needed. The Western pond turtle is a threatened species and to minimize losses, it was decided to contain it within Areas A, B and C. It was desired to allow it to move between its breeding Area A and upland habitat Areas B and C and back again via ground level corridors. The adjacent areas are hazardous so it was important to keep it off the adjoining road, public access areas and the golf course. Since the WPT cannot climb, a simple short 15" high barrier, trenched 5" (Fig 2) and installed around Areas A, B & C would be needed. To tie together fragmented habitat, and allow WPT to move to its upland habitat in Areas B and C and return to its breeding Area A a series of directional corridors were installed.

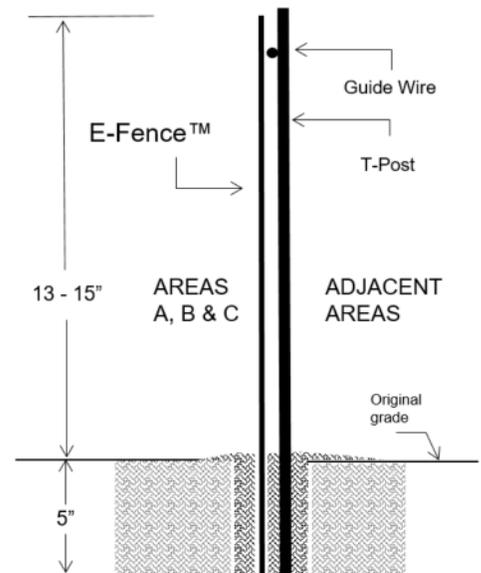
Fig. 2: Simple E-Fence configuration

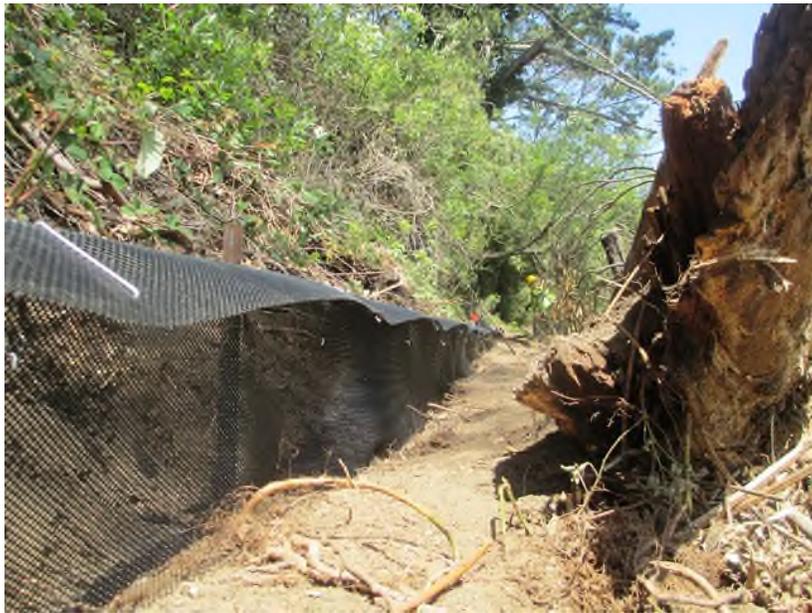
Photo 3: E-Fence™ with 5" climber barrier. About 10" tall and positioned between Mountain Lake and HWY 1 to contain PCF

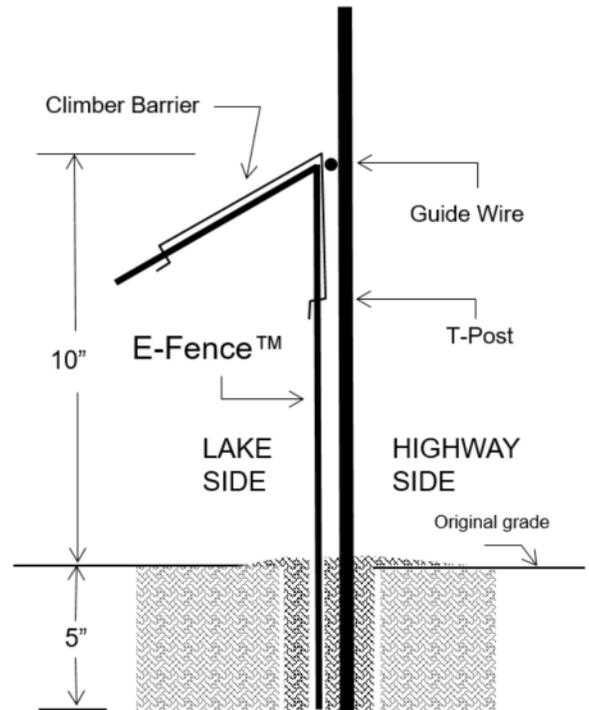
Fig 3: E-Fence™ with a climber barrier along HWY 1

The Pacific chorus frog, not a special-status species, is also native to Mountain Lake. It was decided that it be allowed migrate away from its breeding Area A in any direction except towards the adjacent roadway (HWY 1, west of Area A). At two inches long fully grown, PCF is unable to jump over the WPT barrier, but as an adept climber, it easily can climb over and able to reach all areas. The portion of E-Fence installed along HWY 1 therefore needed a climbing barrier (see Fig. 3).

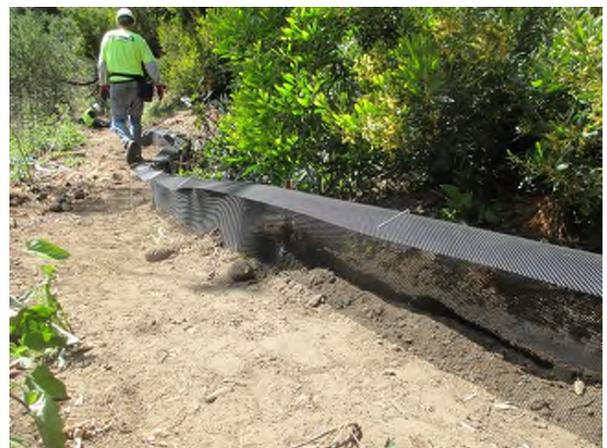
Photo 4: E-Fence™ with climber barrier

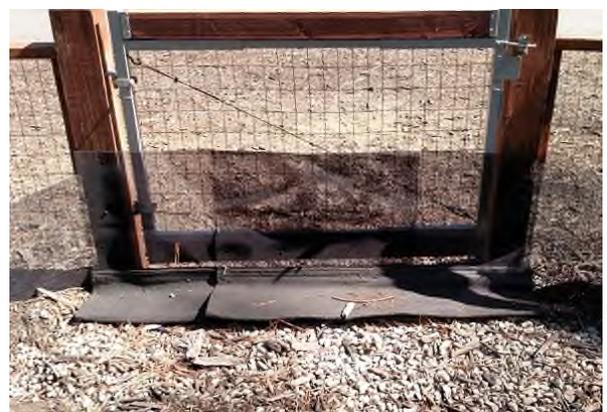
Photo 5: E-Fence™ gate panel with ground sweep for access gates
